**DEPARTMENT OF TRANSPORTATION****DIVISION OF ENGINEERING SERVICES**

Quality Assurance and Source Inspection

Contract #: 04-0120F4Cty: SF/ALA Rte: 80 PM: 13.2/13.9File #: 69.28**WELDING INSPECTION REPORT****Resident Engineer:** Pursell, Gary**Address:** 333 Burma Road**City:** Oakland, CA 94607**Report No:** WIR-004634**Date Inspected:** 17-Oct-2008**Project Name:** SAS Superstructure**OSM Arrival Time:** 700**Prime Contractor:** American Bridge/Fluor Enterprises, a JV**OSM Departure Time:** 1700**Contractor:** Zhenhua Port Machinery Company, Ltd (ZPMC), Changxing Island **Location:** Shanghai, China**CWI Name:** Sun Wei**CWI Present:** Yes No**Inspected CWI report:** Yes No N/A**Rod Oven in Use:** Yes No N/A**Electrode to specification:** Yes No N/A**Weld Procedures Followed:** Yes No N/A**Qualified Welders:** Yes No N/A**Verified Joint Fit-up:** Yes No N/A**Approved Drawings:** Yes No N/A**Approved WPS:** Yes No N/A**Delayed / Cancelled:** Yes No N/A**Bridge No:** 34-0006**Component:** Tower**Summary of Items Observed:**

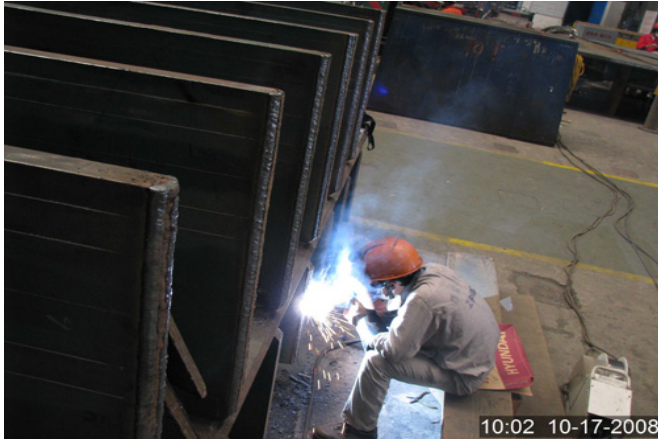
### South Shaft, Skin C, Lift 1

ZPMC was in the process of building up the longitudinal stiffeners and skin plate by welding (buttering) utilizing the flux cored arc welding process. ZPMC's internal weld repair report stated the amount of buttering would be 8 mm. QA observed as much as 15 mm. Below is a digital photograph illustrating the build up in progress.
